# Joint High Speed Vessel (JHSV)

# Follow-on Operational Test and Evaluation (FOT&E) Report

# September 2015

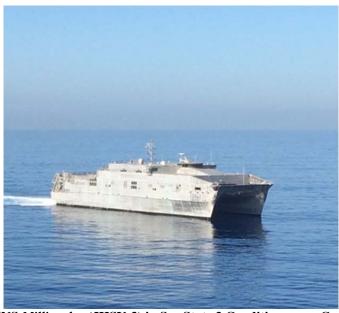
Figure 3. USNS Millinocket (JHSV-3) in Sea State 3 Conditions near Camp Pendleton

Figure 3 shows USNS *Millinocket* the day of the second test in Sea State 3 conditions. The seas in Figure 2 look very calm, but data from the nearby National Oceanic and Atmospheric Administration buoy indicated a swell from the south with significant wave height of 2½ feet (0.7 meters) and a 12½-second period, which technically meets the North Atlantic Treaty Organization Sea State definition for Sea State 3.

Although the seas in the lee of MLP (CCS) (an area sheltered from the wind and waves), where JHSV was moored, were estimated to be Sea State 1 to 2, the vehicle transfer test failed. Figure 4 shows the two ships moored skin-to-skin with the JHSV ramp deployed. The hydraulic ram used to swing the ramp port to starboard tore free from its anchor point on the JHSV transom. The small amount of movement between the ships, even in calm Sea State 1 to 2 conditions, was enough to cause the damage when a truck pinned the foot of the ramp onto the raised vehicle deck of MLP (CCS) as it transited the ramp. The physical strength of the ramp was not compromised; the Marine Corps truck returned to JHSV, but this ended the vehicle transfer portion of the test. The Navy has not made any design changes to the JHSV ramp to enable these transfers. JHSV is not effective for operations with MLP (CCS) unless in Sea State 1 conditions, which is an unacceptable constraint for operational deployment.

In order for the Navy to conduct open ocean equipment transfers between JHSV and MLP (CCS), DOT&E recommends that the Navy modify the JHSV ramp to increase its sea state rating, or develop a new, higher sea state rated ramp, then retest at-sea equipment transfers with MLP (CCS).

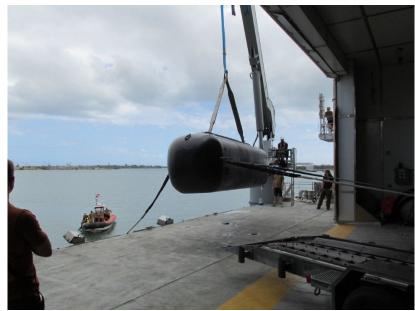
Figure 5. SDV Suspended While Trailer is Removed

The launch of the SDV is deceptively simple. Figures 5 and 6 show the SDV after it was lifted from the trailer during a pier-side test, and just before it was placed in the water during an underway test.

Two other items of concern uncovered by this test are the vulnerability of the SDV to a pendulum swing motion while suspended by the crane, and the possible effects on SDV operators and passengers from JHSV engine exhaust. While suspended, the SDV was vulnerable to pendulum motions during both the open-ocean launch and recovery of the SDV events, and the tending line personnel were challenged to control this. As noted, the significant wave height indicated Sea State 3 conditions during the open-ocean portion of the test. As shown previously in Table 2, the open-ocean launch time, from lifting the SDV from the trailer, launching it, and then clutching in the JHSV engines, took 3 minutes. As shown previously in Table 3, the recovery from declutching engines to placement of the SDV in the trailer cradle took 16 minutes. The extended recovery time was due to the challenges the line tenders experienced controlling the pendulum motions of the SDV. A mitigating factor for actual missions may be, by default, a Sea State 2 limitation. The support boats for this test operated from shore, but in actual operations, the boats would be launched by JHSV prior to launching of the SDV. JHSV's IOT&E demonstrated that launch or recovery of these type boats was limited to Sea State 2. At Sea State 2, the pendulum motions of the SDV should be less. Alternatively, the crane could be upgraded with a pendulation control system.

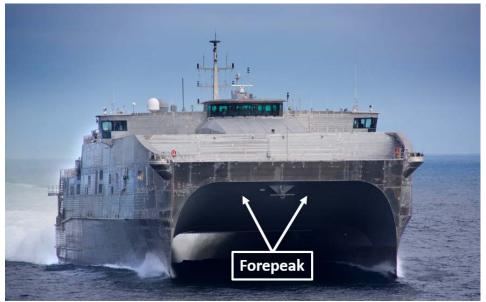
Figure 18. JHSV Forepeak

The entire ship class requires reinforcing structure for the bow structure in the forepeak space, which is the forward structure of the ship between the two hulls, as shown in Figure 18. The American Bureau of Shipping originally recommended that the bow structure in the

forepeak area be built to withstand 26.1 pounds per square (psi) loading caused by wave slamming. The ship manufacturer, Austal USA, proposed a revised Safe Operating Envelope (SOE) to eliminate the likelihood of head seas and recommended a design to withstand pressures up to only 17 psi. The ship design manager approved the Austal USA proposal and the Navy Program Manager concurred.

- Continue aggressively determining the root cause of ship service diesel generator casualties and fixing them fleet-wide.
- Evaluate whether repairs and alterations to the waterjet reversing buckets, along with
  alterations to the ship autopilot system, resolve the failure mode of this equipment, or,
  alternately, investigate a replacement schedule to minimize waterjet casualty
  downtime.
- Evaluate whether the repairs and alterations to the internal operating mechanism of the forward ride control foils resolves the failure mode.
- Complete structural reinforcement of bow structure on remaining ships of the class.
